**REPORT ON THE GEOTECHNICAL INVESTIGATION CARRIED OUT  
FOR THE PROPOSED RESIDENTIAL DEVELOPMENT ON THE  
REMAINDER OF ERF 582 BEDFORDVIEW EXTENSION 113  
GAUTENG PROVINCE**

**Detail reporting stage**

**Geo Simplicity Geotechnical Engineering (Pty) Ltd**

*Ref: G687-PVS-R01*

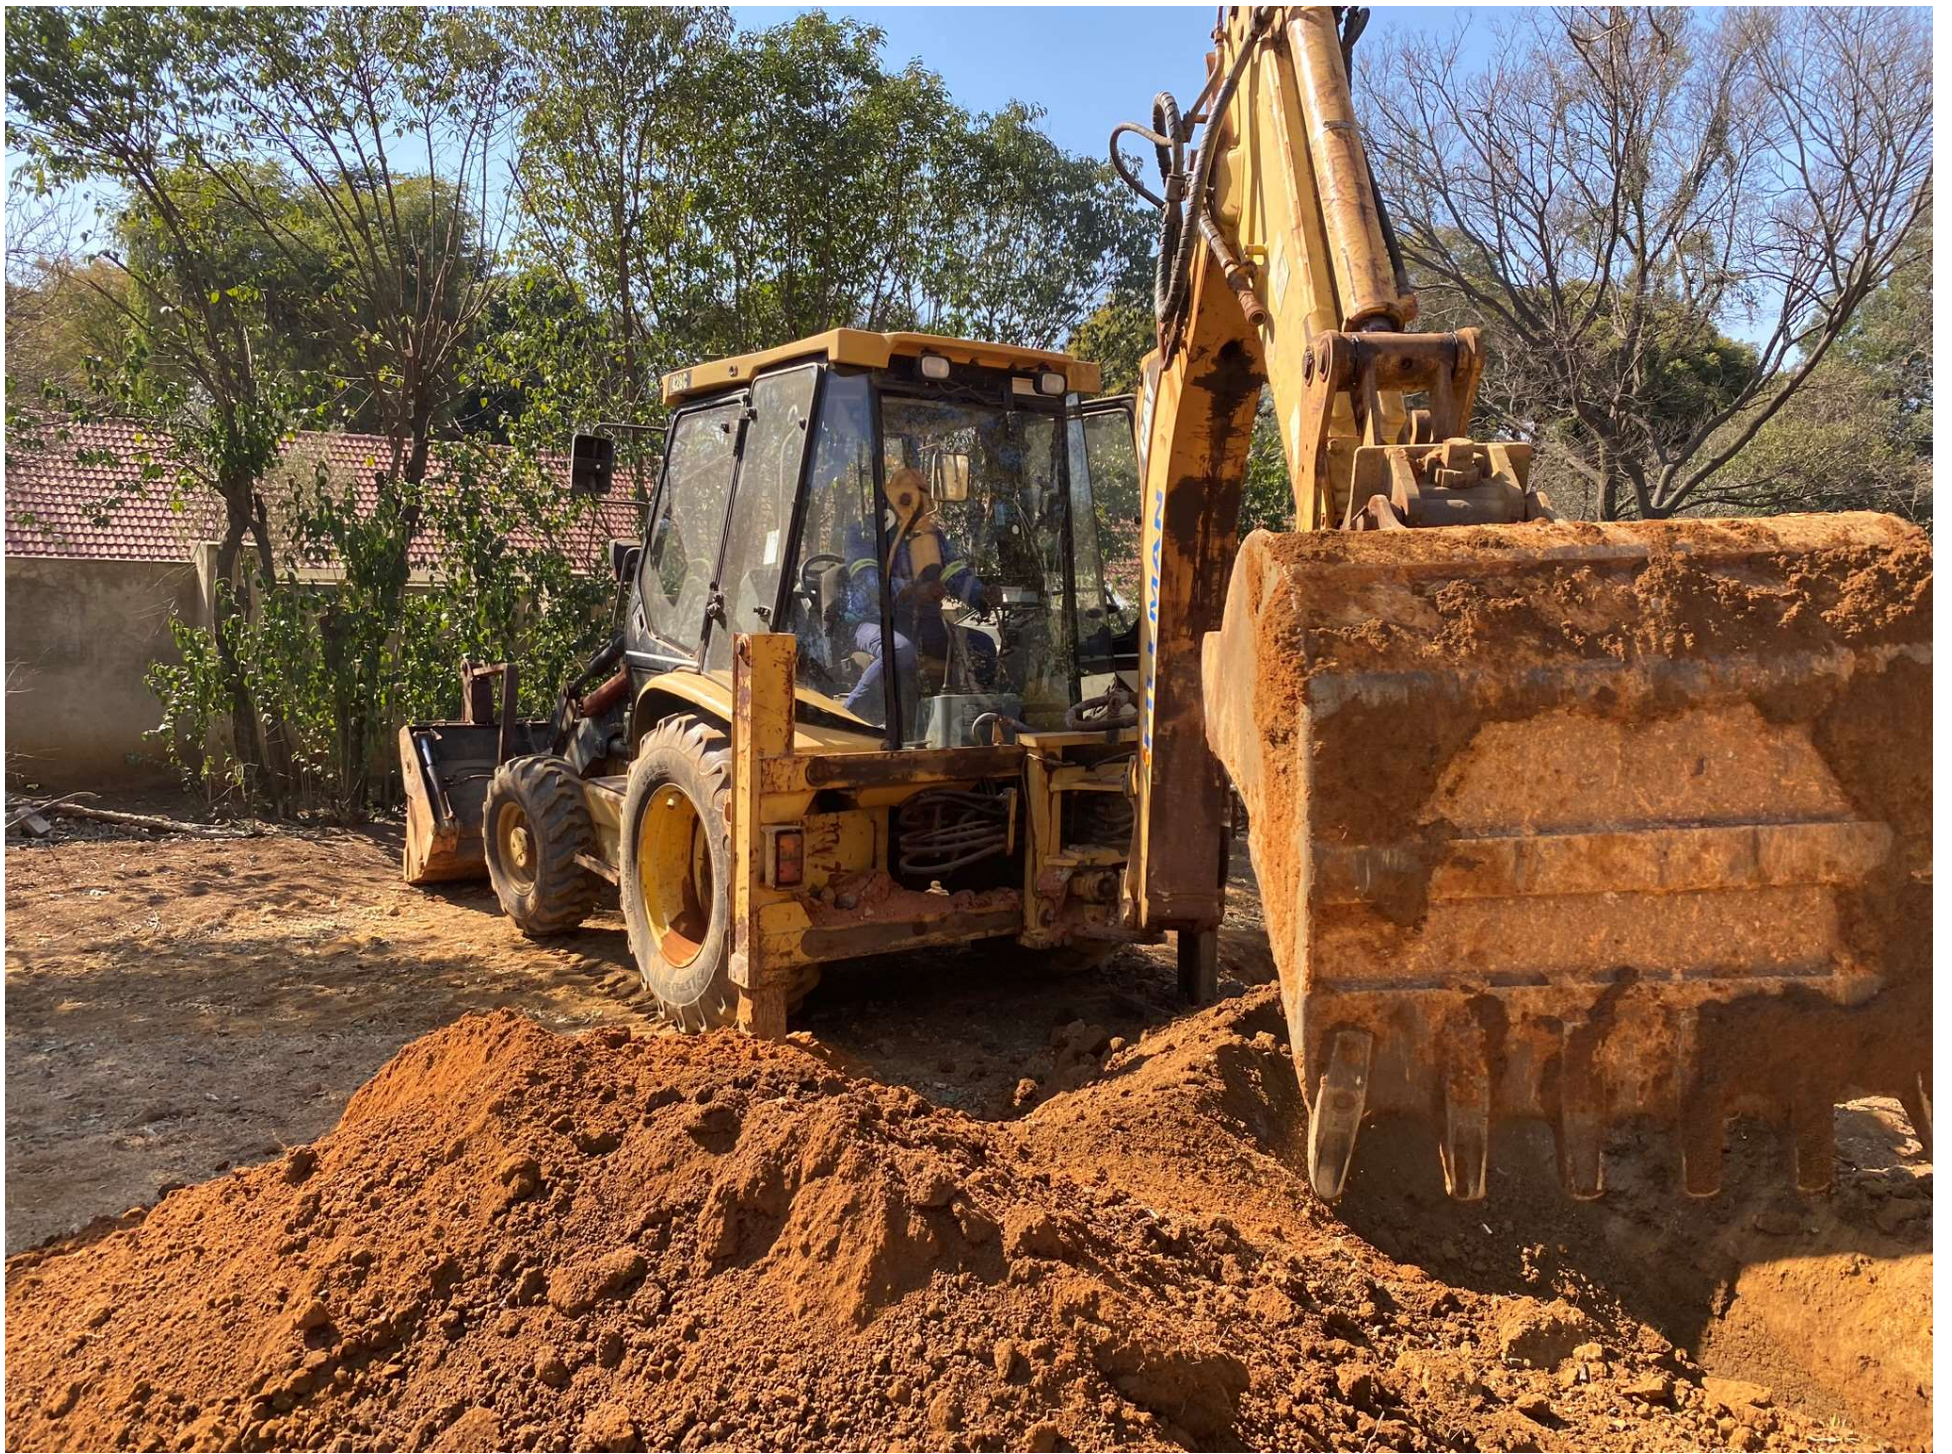
Digging of test holes

The machine was in an excellent working condition with no mechanical problems to be reported, allowing effective advance to its maximum digging reach which was established to vary between 3,0m and 3,3m below Ground Level at Geotechnical (GLG) investigation stage, pending on the machine's orientation during digging.

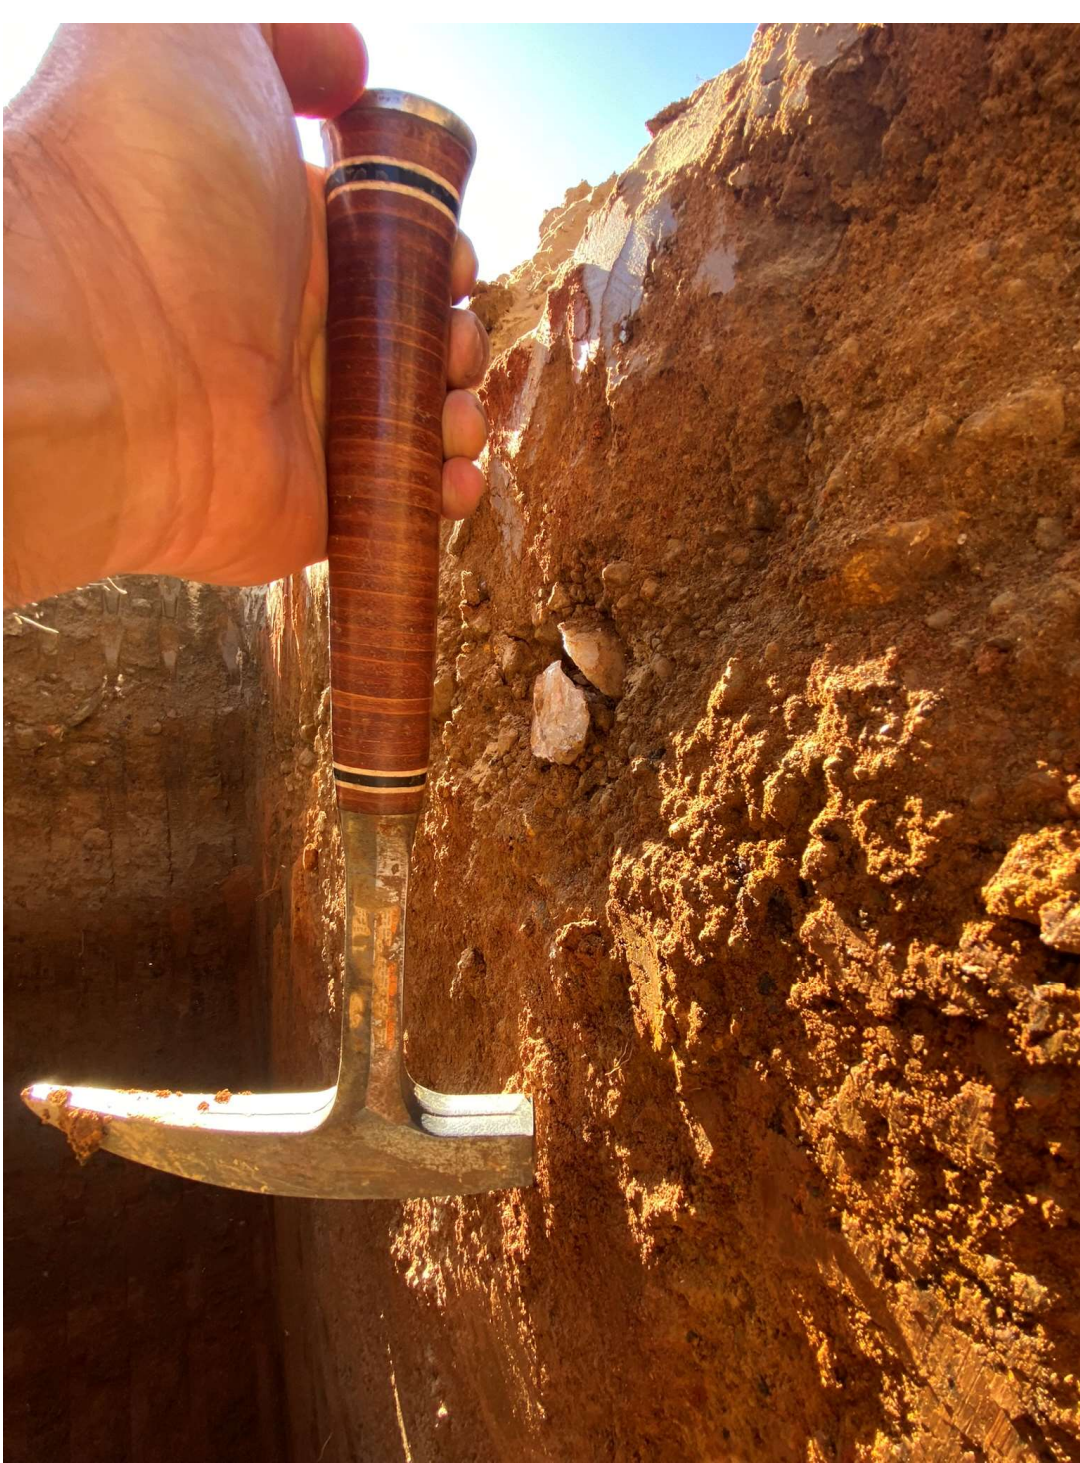
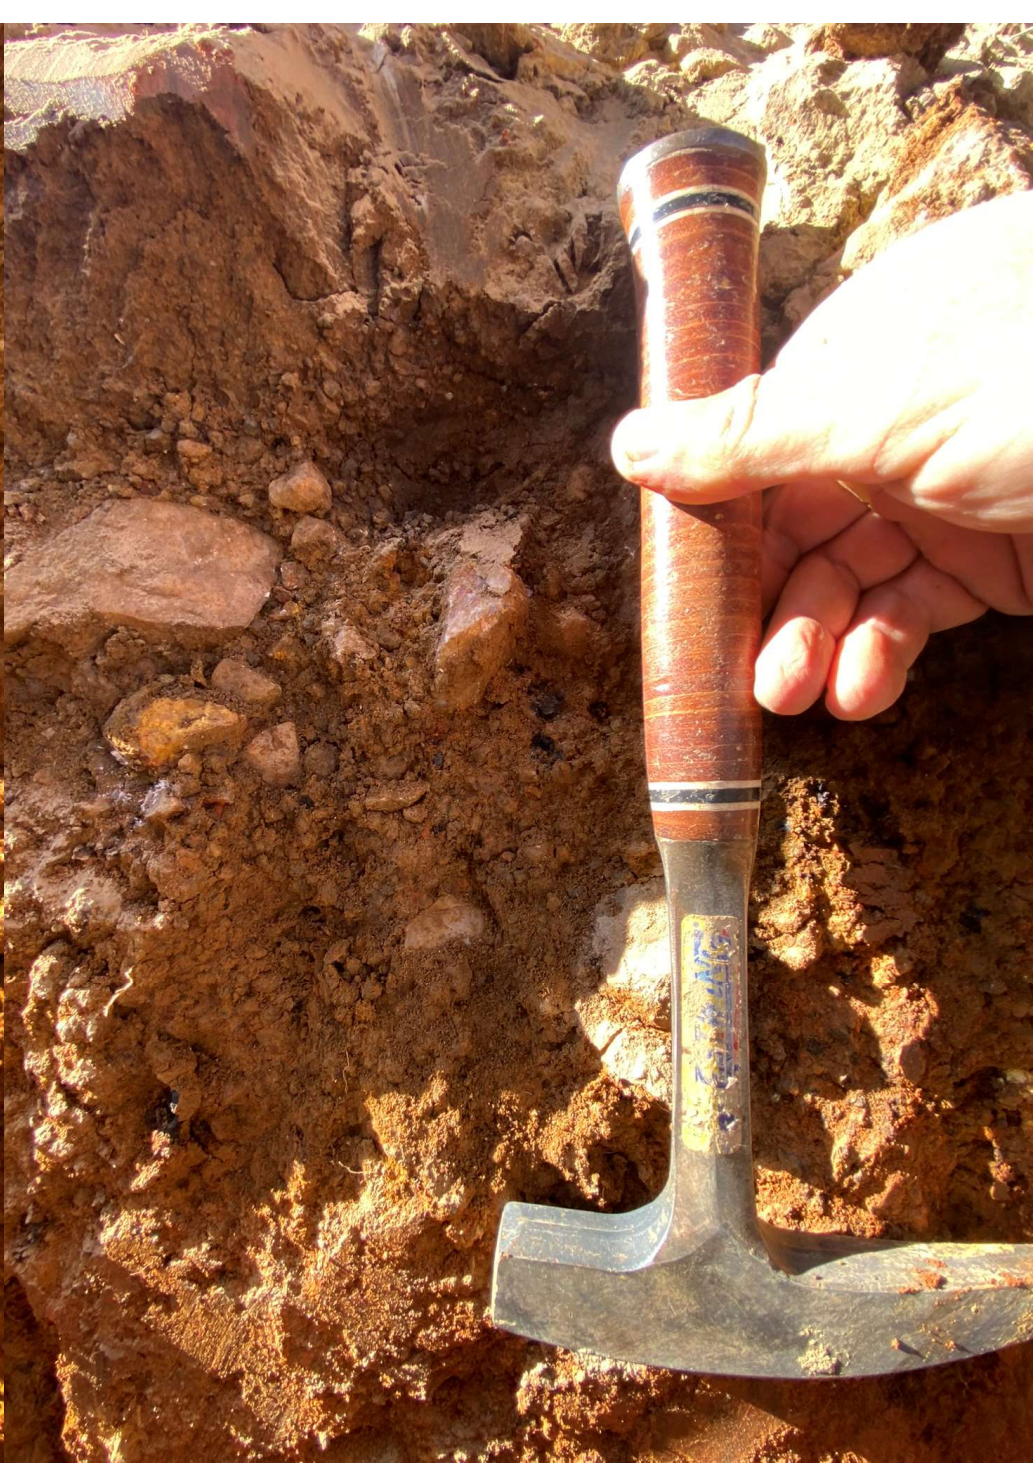
Upper hillwash transported underlain by the pebblemarker transported with depth

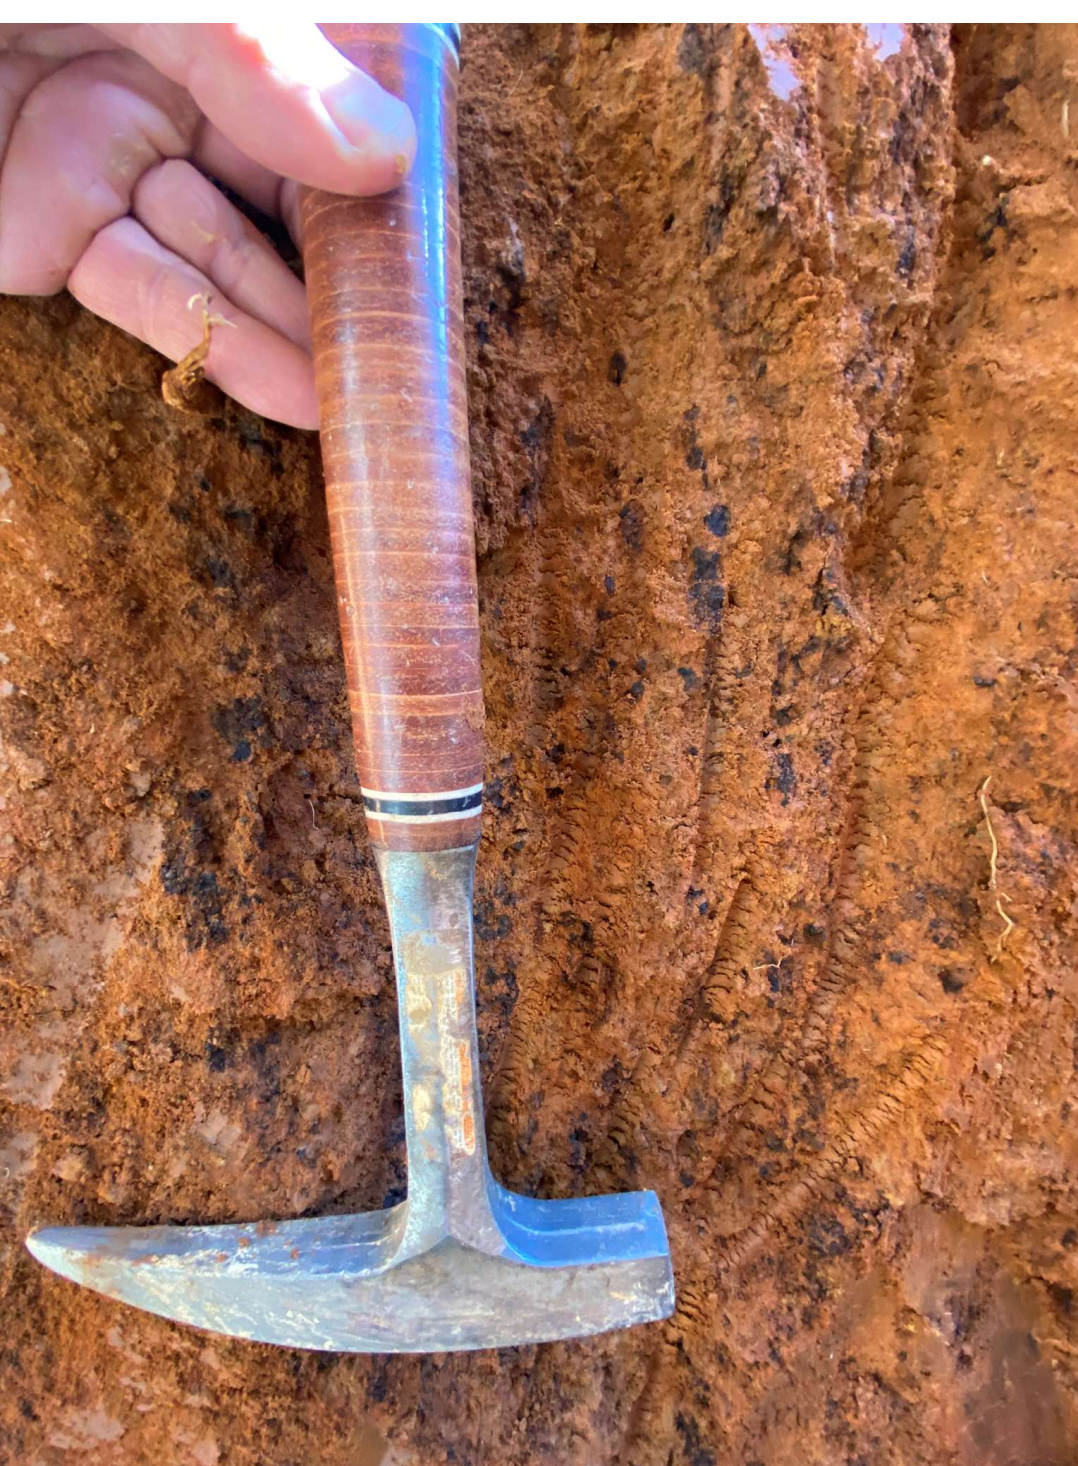
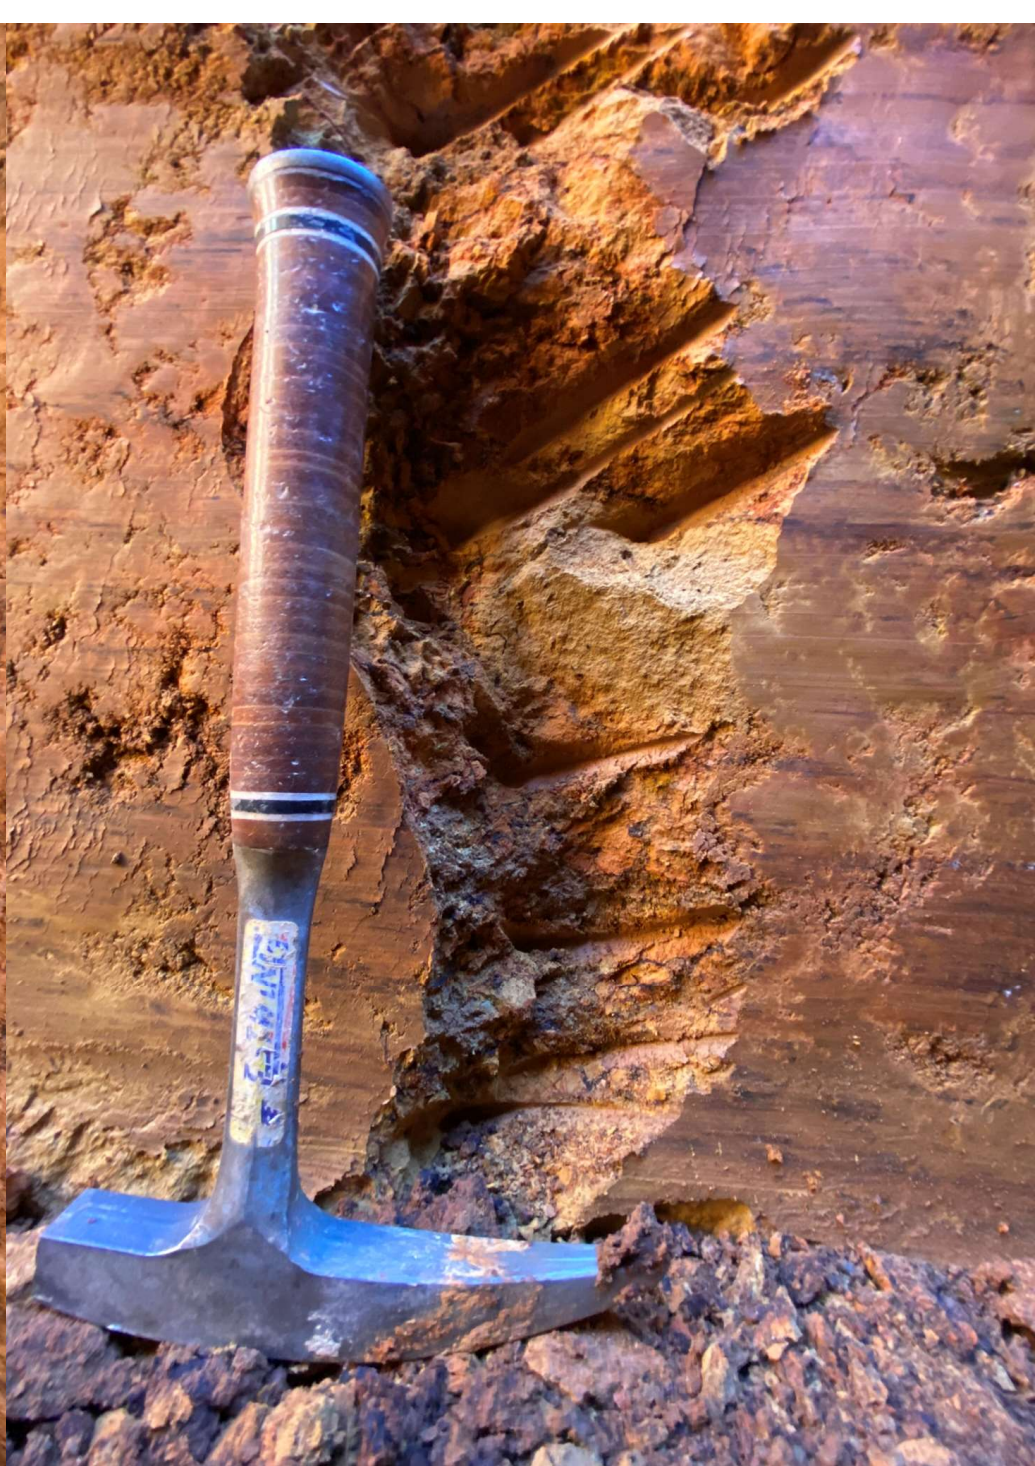
Left: Reworked residual lava, and  
Right: Residual lava encountered

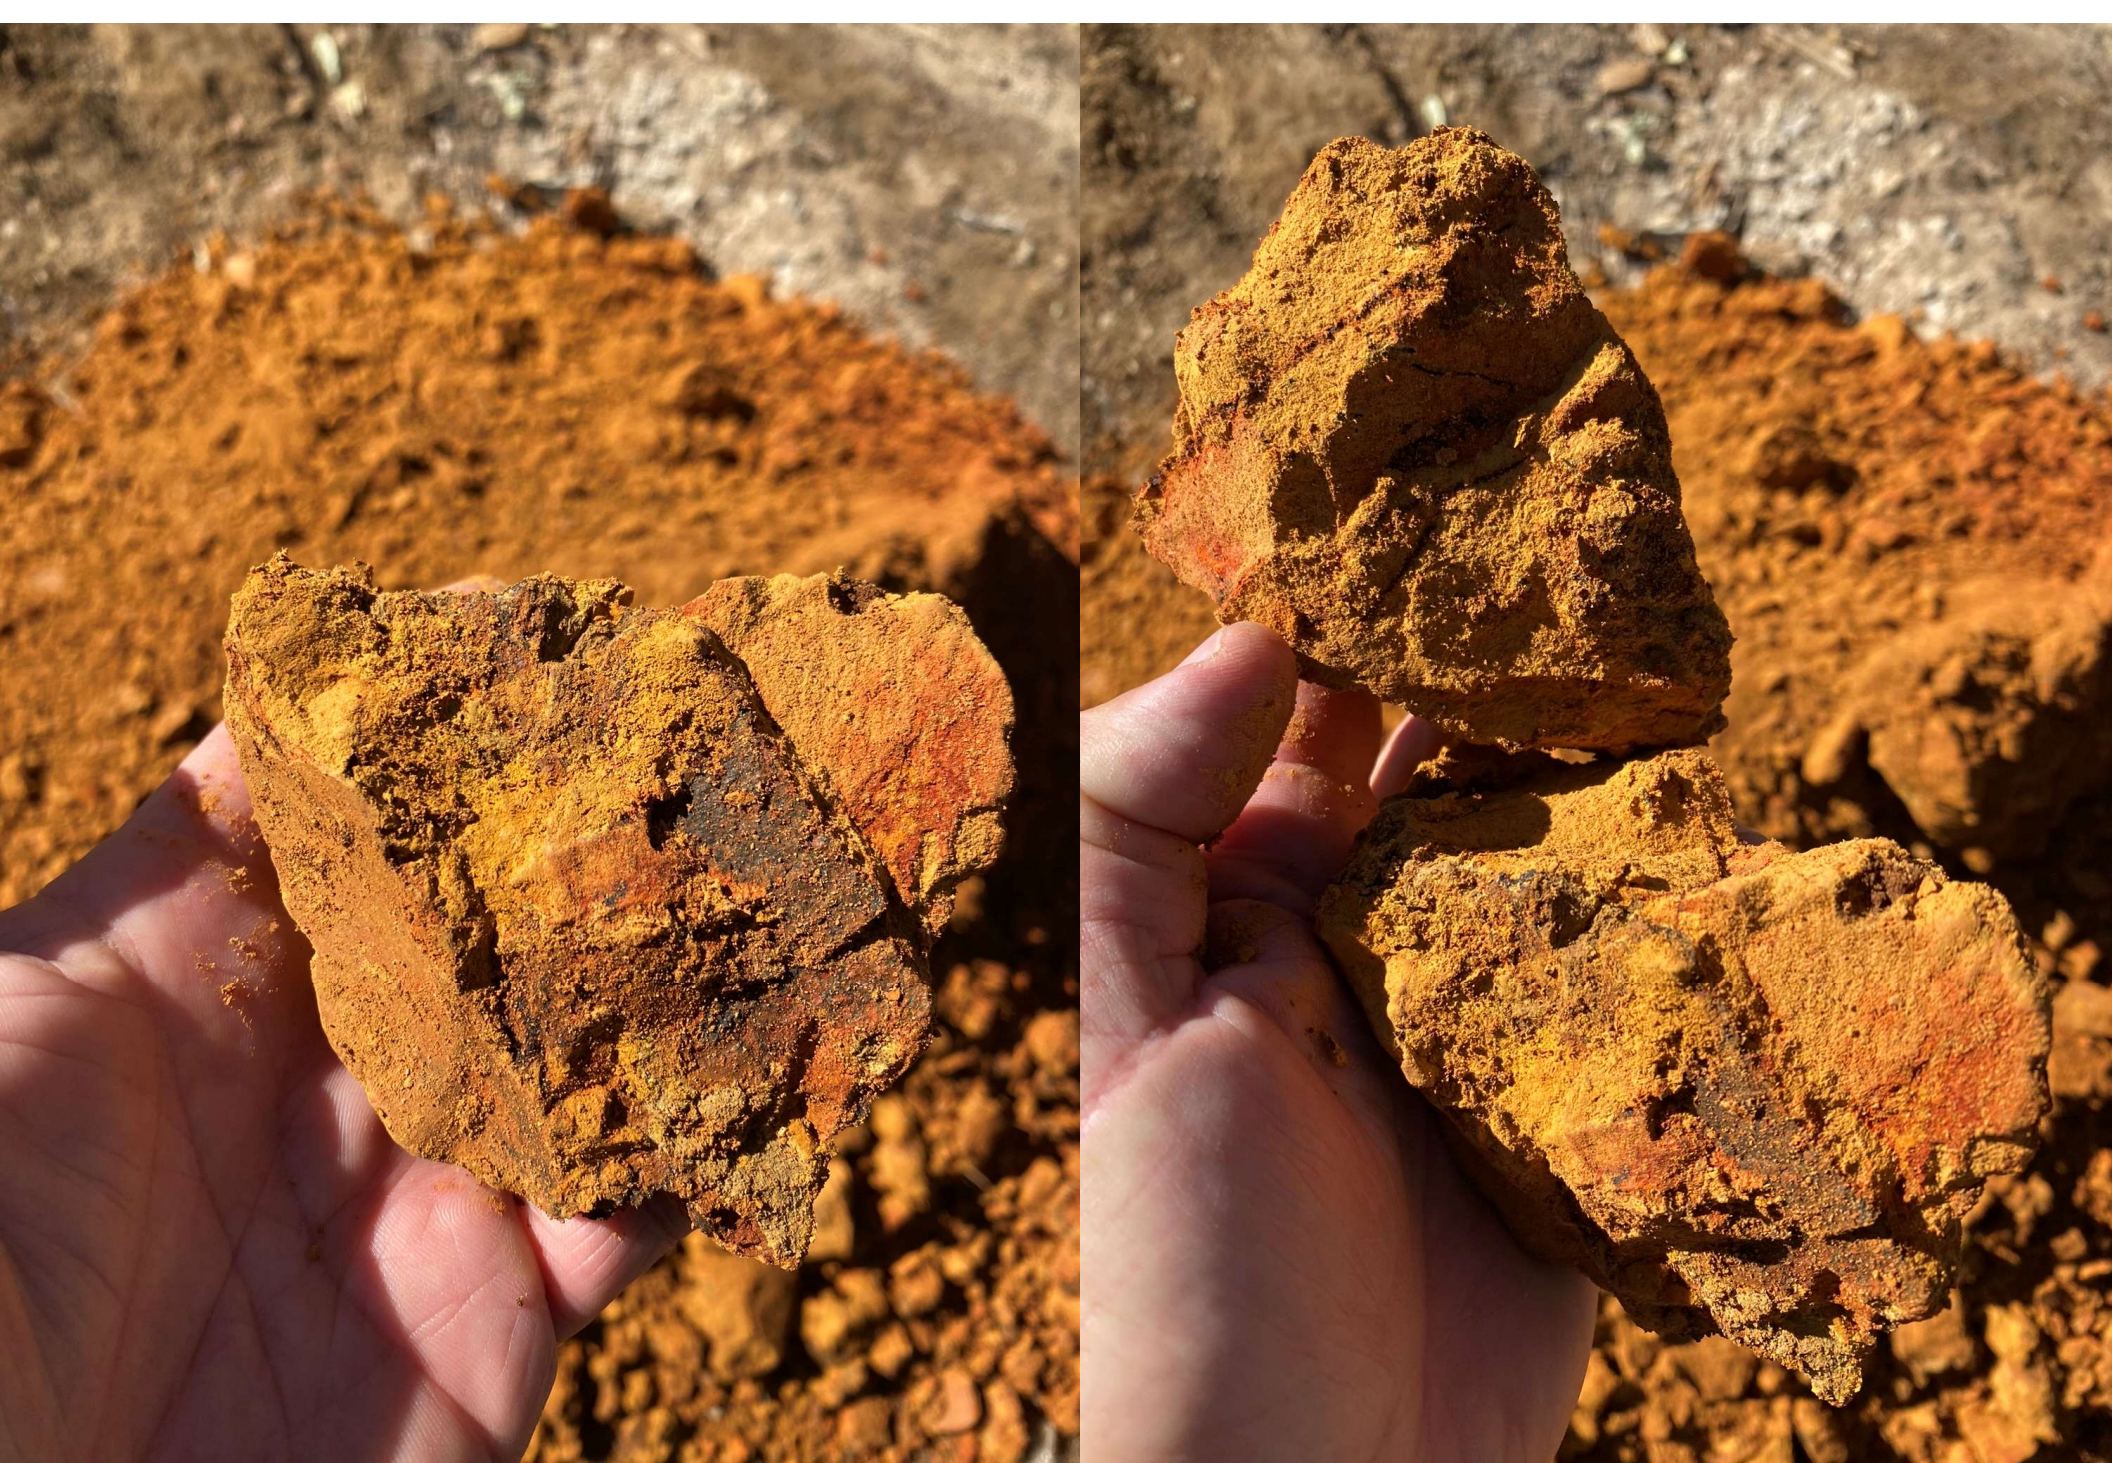
Close-up view of stiff, residual lava, where encountered
